HOCKANUM RIVER BASIN
VERNON, CONNECTICUT

SHENIPSIT LAKE DAM
CT. 00209

PHASE I INSPECTION REPORT
NATIONAL DAM INSPECTION PROGRAM

SEPTEMBER 1978

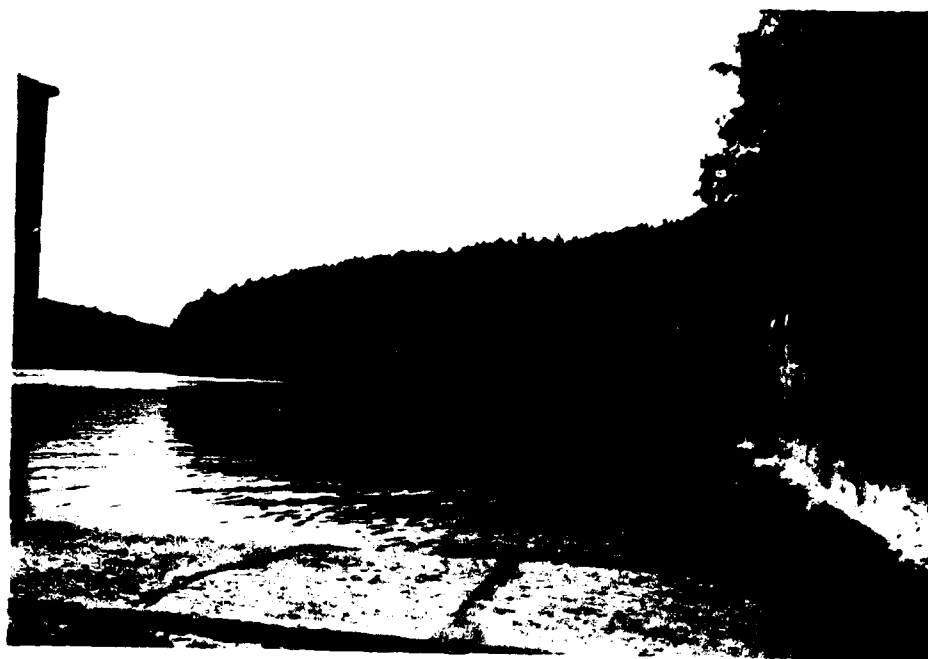
PHOTO 1
UPSTREAM EMBANKMENT RETAINING WALL

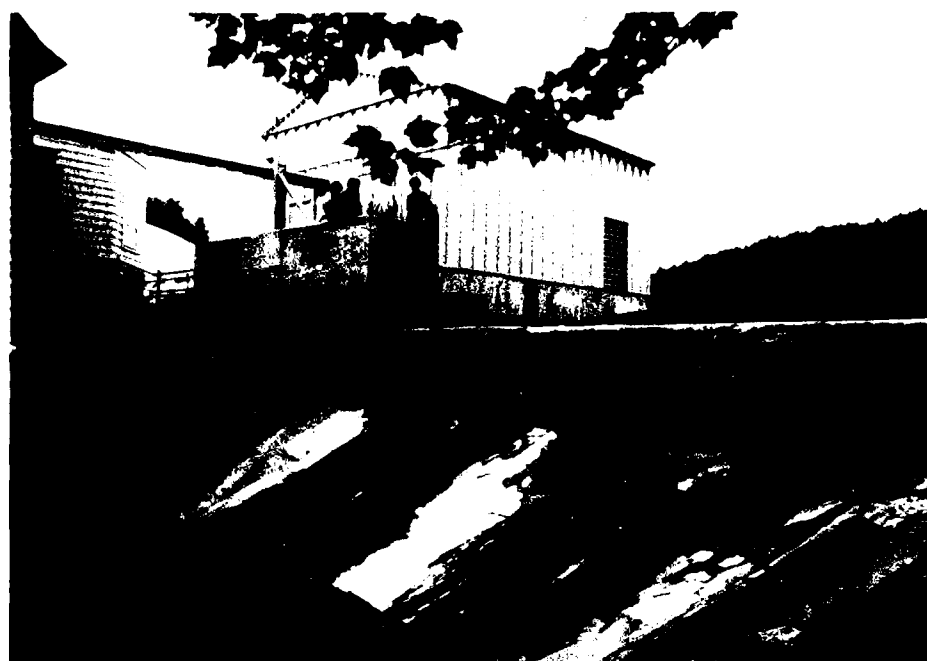
c. Appurtenant Structures - The upper gate house was reconditioned in 1968 in conjunction with the construction of the water treatment plant. Our inspection showed the structure to be in good condition except for water that was leaking into the intake well through the joints in the granite blocks. It appears that the chemical content of the

PHOTO 3
SPILLWAY - UPPER GATE HOUSE

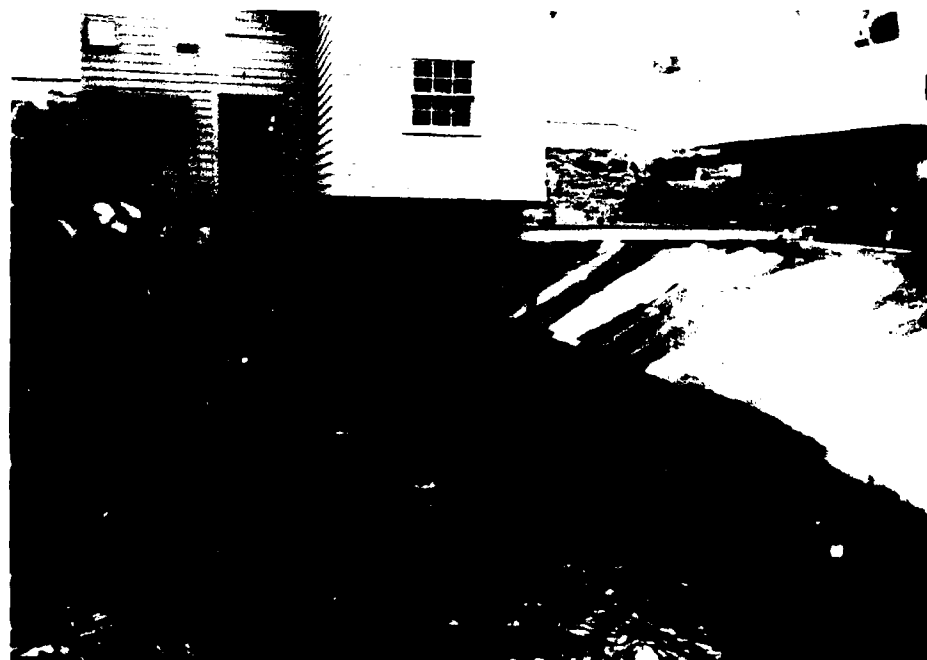
PHOTO 4
SPILLWAY - LOWER GATE HOUSE

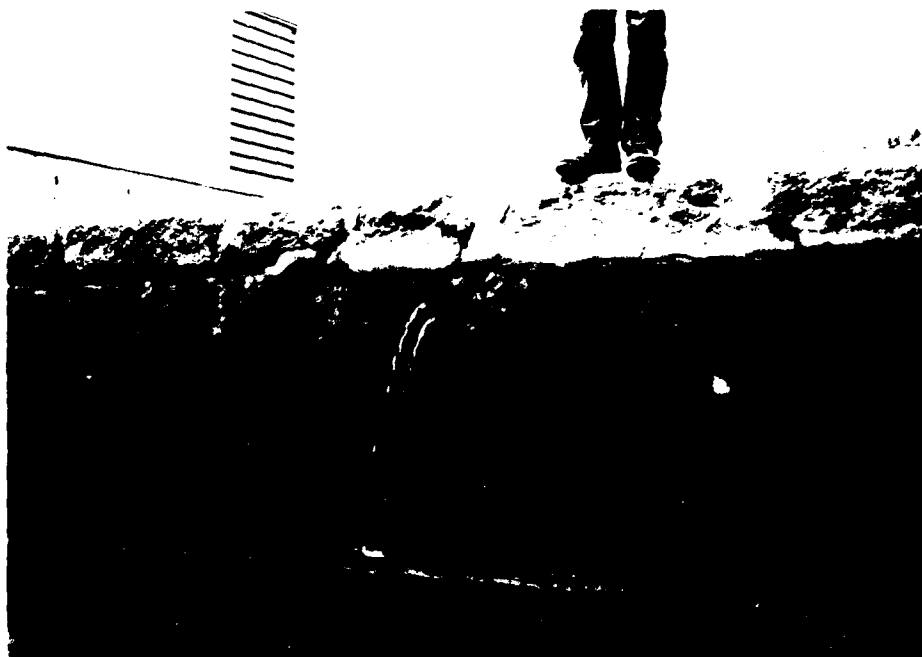
b. Dam - The body of the dam is made up of granite block stone masonry with mortared joints. There were several minor leaks from the joints in the face of the spillway. The condition of the mortar beneath the surface could not be determined. The relationship of the dam to the adjacent rock surfaces showed no evidence of slippage or movement. Measurement of the seepage discharge from the face of the dam was approximately 5 to 6 gallons/min. Photographs taken in October, 1976 which were made available by the owner showed the area in back of the spillway at a lowered water surface elevation. The photographs did not indicate areas of distress.

PHOTO 5
SPILLWAY - LEAK

- a. Alternatives - Not applicable.
- b. O & M Maintenance and Procedures -
 1. The seepage through the stone masonry and the empty joints between the stones of the dam, the well of the upper gate house and the retaining walls should be repaired.
 2. An operational and maintenance manual should be developed.
 3. The warning system for flood conditions (Appendix B) should be reviewed and coordinated with state and/or local officials.

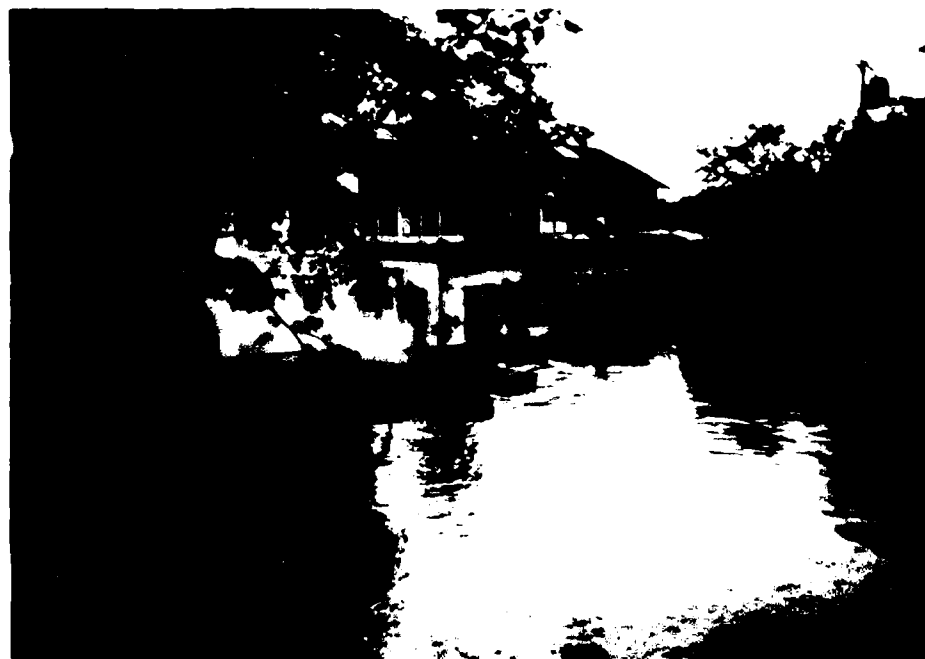
PHOTO 10
DAM 200'± DOWNSTREAM
